Failure analysis of six-cylinder diesel engine

Abstract: Reliability of engines for longer run has been a prime concern for Maharashtra State Road Corporation Transportation (MSRCT). This project deals with finding the maximum causes of failure in the TATA-CUMMINS six-cylinder diesel engine and giving recommendation for reducing the engine breakdown. The maximum failure was observed for cracking of the cylinder bore, which caused complete engine to be scrapped and causing heavy financial loss to State Transport (S.T.) Workshop, Dapodi, Pune. About 100 TATA-CUMMINS 697 engines were inspected for the engine failure and following results were obtained. Remedies for reducing the failure have been suggested at the end of paper.

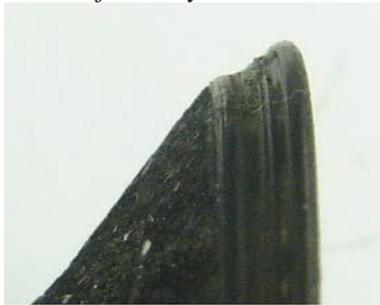
Fig.3.1a wear at seat region

- Check the alignment between the components: spring/disc/valve guide/seat. Clearance and correct applications shall be checked;
- Check synchronization and avoid excessive engine speed;
- Follow the engine manufacturer's recommendations, with respect to the engine's regulation of the fuel injection system .

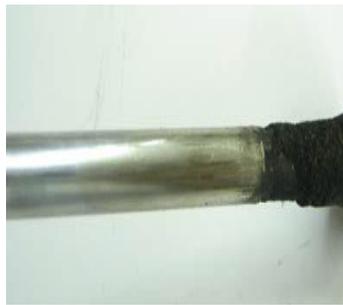
Fig.3.1b scuffing at valve guide

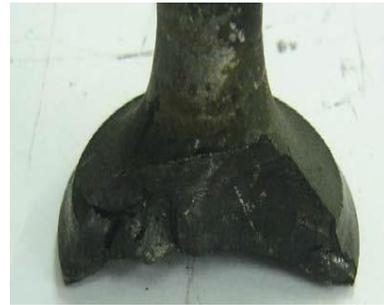
Fig.3.1c breakage of valve

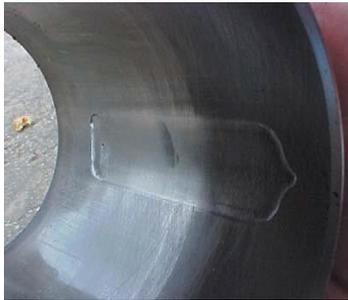
Fig.3.2a circlip explosion

- Keep the dimensions of the cylinder liner seat at the engine block according to recommendations given by the manufacturer/producer.
- Follow the engine manufacturer recommendations when fitting the cylinder liners at the engine block.
- Machine correctly the cylinder liner seat at the engine block.
- Keep all cooling system components (reservoir and/or radiator cap, hoses and clamps, thermostatic and pressostatic valves, water pump, etc.) in normal running conditions, compatible with the engine.
- Always use the corrosion inhibitor additives and the anti-freezing fluids, as recommended by the manufacturer/producer of the engine

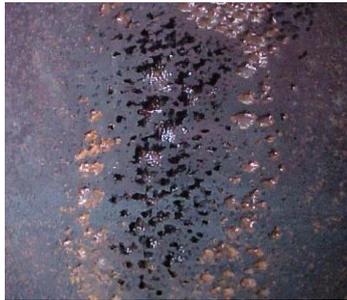
- Cavitation - During the engine running, the cylinder liners are submitted to pulsations, which are the consequence of the air/fuel combustion in its interior. When the combustion occurs, the cylinder wall expands fractions of a millimeter, due to the pressure of the expanding gases against the inner walls. This cause perforation of the wall.[3]

Fig.3.2b cavitation with scales

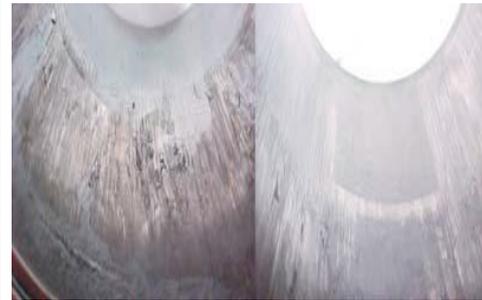
- Irregular contact between the cylinder liner and the housing can impair the thermal exchange between the two and, consequently, can result in scuffing between the piston and the cylinder liner;

Fig.3.2c scuffing on inner side

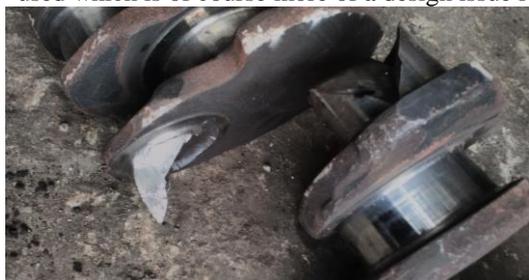
- **Fatigue failure:** Majority of steel crankshaft failure occurs because of fatigue failure, which may originate at the change of cross-section such as at the lip of oil hole bored in the crankpin.
- **Insufficient lubrication:** If the lubrication of bearing in the crankshaft is starved, it may lead to wipe out of the bearing and failure of the crankshaft.
- **Over pressurised cylinder:** It may happen that there is hydraulic lock (water leakage) inside the liner and due to extreme pressure the crankshaft may slip or even bent (if safety valve of that unit is not working).
- **Cracks:** Cracks can develop at the fillet between the journal and the web, particularly between the position corresponding to 10 o'clock and 2 o'clock when the piston is at T.D.C.[2]

Fig3.4a cracking of crankshaft

- Alignment of crankshaft should be checked regularly.
- Bearings should be replaced at adequate timespan, all bearings should be bought from same manufacturer as different manufacturer use different materials.
- Clean and proper grade of lubricating oil should be used in engine, oil should be regularly checked for its PH value to ensure that it is not acidic in nature.
- Since the bedplate and the foundation bolts acts as a base for the proper support of the crankshaft both these should be kept in order. The bolts should be properly tightened while a rigid bedplate should be used which is of course more of a design issue rather than in the hands of the engineer on duty

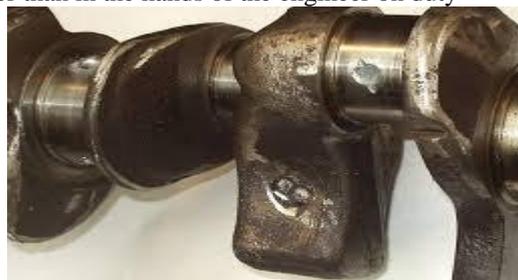
Fig3.4b wearing of journal

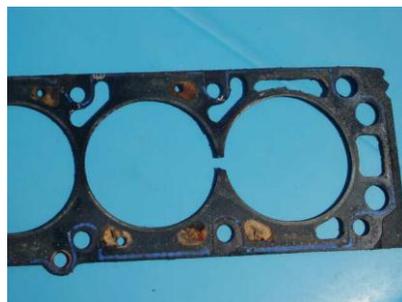
Fig.3.5a worn-out gasket

- Proper coolant levels should maintained in the radiator, this will allow engine to cool properly and prevent failure
- For gasket to fit properly the surface of the engine block and head should be machined smooth and flat .
- The head bolts used to secure a gasket are important in maintaining the cylinder seal. A deformed thread in the engine block surface can destabilize the gasket's placement. Similarly, the bolt itself must be in good shape to increase the chance of a reliable seal

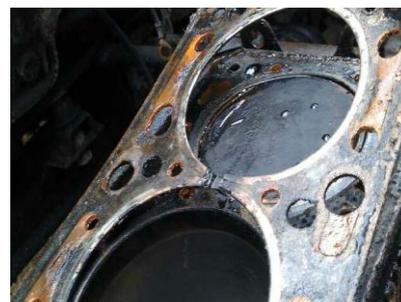
- One cause of head gasket failure is pre-ignition: As fuel is combusted at unwanted times during an engine's cycle, large pressures can occur within the cylinder head as the engine begins to work against itself. These spikes in pressure can put strain across the head gasket, causing it to fail[13].
- Overheating is another possible cause, as the gasket is placed under conditions over and above its design criteria, resulting in warping and permanent damage. This can be purely down to coolant leaks from a corroded radiator or dodgy piping, or it could be pre-existing failures in the head gasket.
- Poor gasket design can also lead to premature failure of gasket.

Fig.3.5b blown gasket
